# Manhole Inspection Summary

Manhole # S09WW1001MH

Insp Date: **8/1/06 9:28 AM**

**Location** Address: **5505 RUSK AVE**

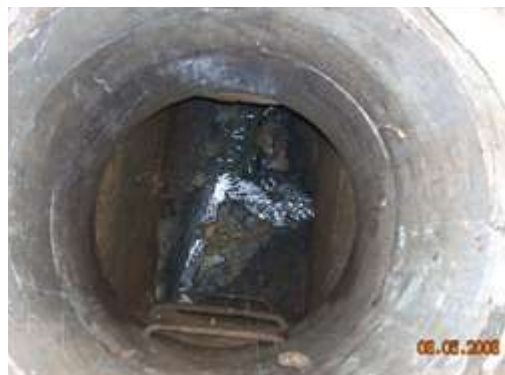
Top View

Corroded and missing steps. Evidence of surcharge - Bench debris. Channel debris.

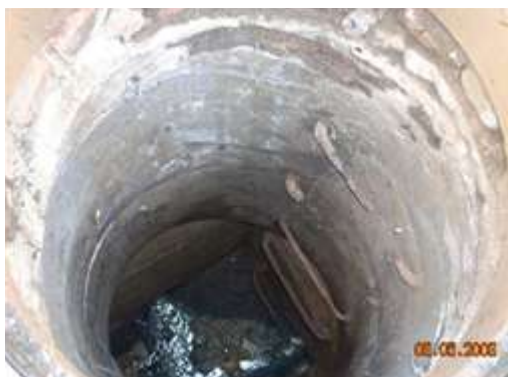
Defect

Frame leaks. Adjustment deterioration and infiltration. Corbel and Barrel infiltration - other side.

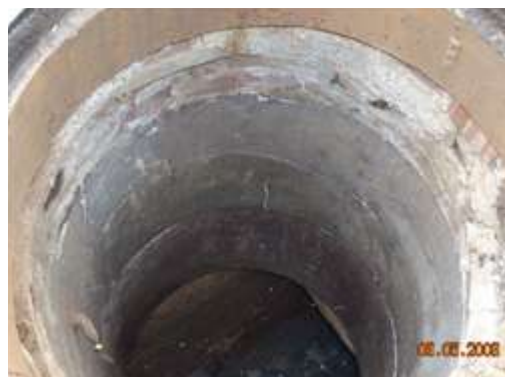
Defect

Frame leaks. Adjustment deterioration and infiltration. Corbel and Barrel infiltration.

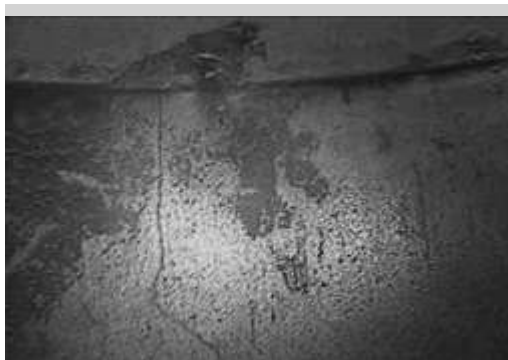
Defect

Corbel cracks and infiltration.

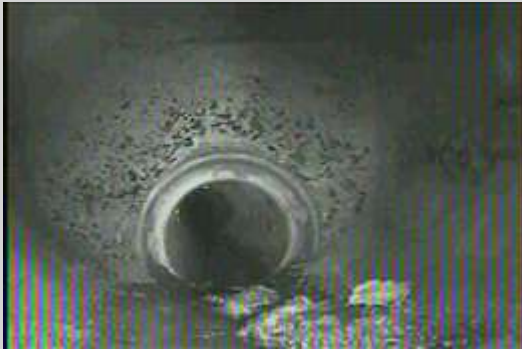
### 8 in. Circular Gravity Sewer Pipe Out @ 12 O'Clock

Infiltration: **Evidence** Pipe Seal Cond: **Unknown**

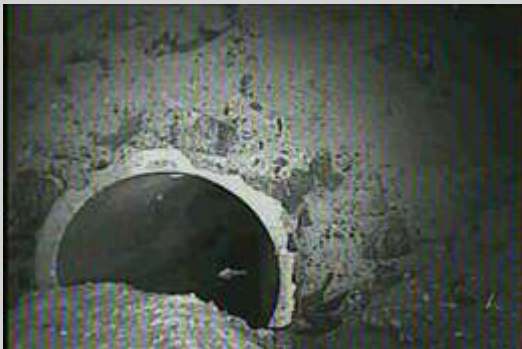
### 6 in. Circular Gravity Sewer Pipe In @ 3 O'Clock

note debris

Deposits: ☐ None ☒ **Mud** ☐ Sludge ☒ **Debris** ☐ Grease

Silt Depth: **2** (in.) Deposits Extent: **Medium**

Infiltration: **Evidence** Pipe Seal Cond: **Unknown**

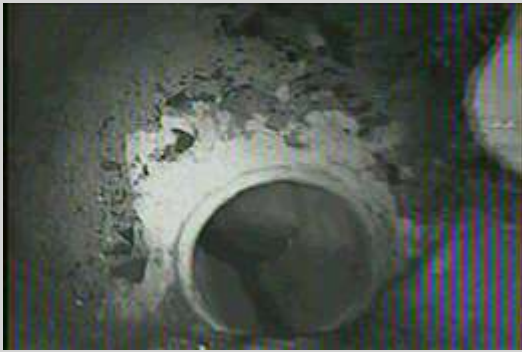
Pipe In @ 6 O'Clock

Infiltration: **Evidence** Pipe Seal Cond: **Unknown**

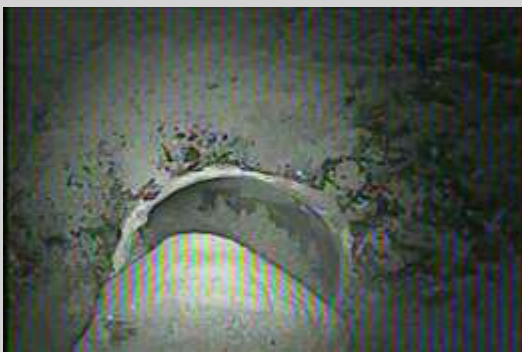
Pipe In @ 9 O'Clock

Deposits: ☐ None ☐ Mud ☐ Sludge ☒ Debris ☒ Grease

Silt Depth: **3** (in.) Deposits Extent: **Medium**
